YOUR Inspection Report

123 Hometown Street
Anywhere, PE

Friday, April 2, 2010

RE: Report No. 1179, v.3
123 Hometown Street
Anywhere, PE

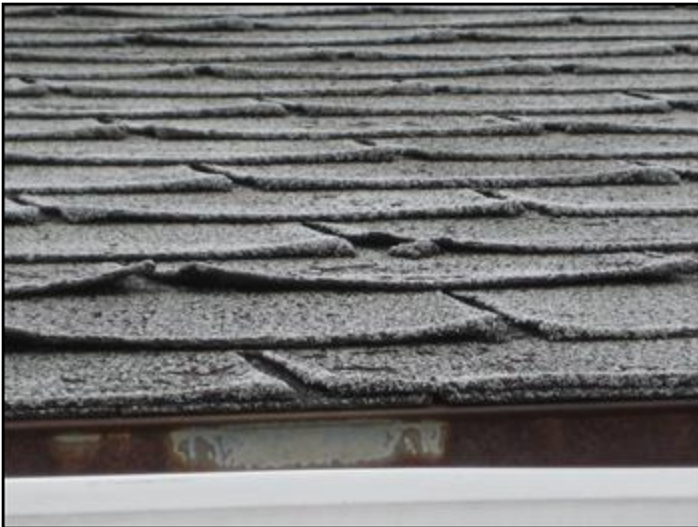
1.

Condition: • [Near end of life expectancy](#)

Location: Throughout Roof

Task: Replace

Time: Immediate

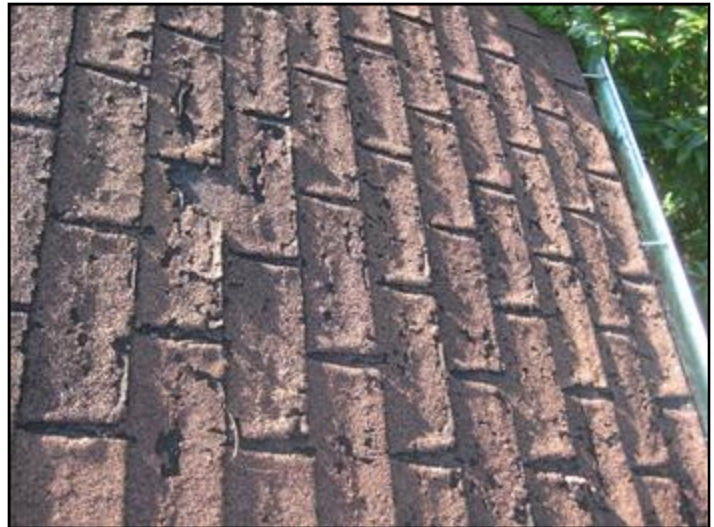
2.

Condition: • [Cupping, curling, clawing](#)

Risk of leaking is high.

Location: Throughout Roof

Task: Replace

Time: Immediate

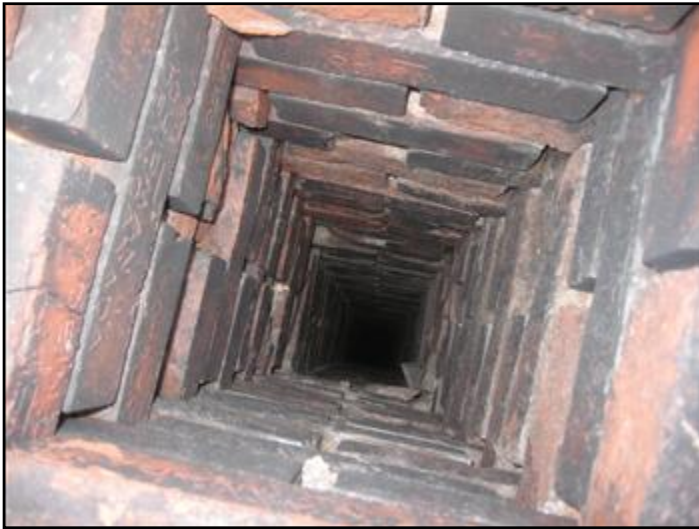
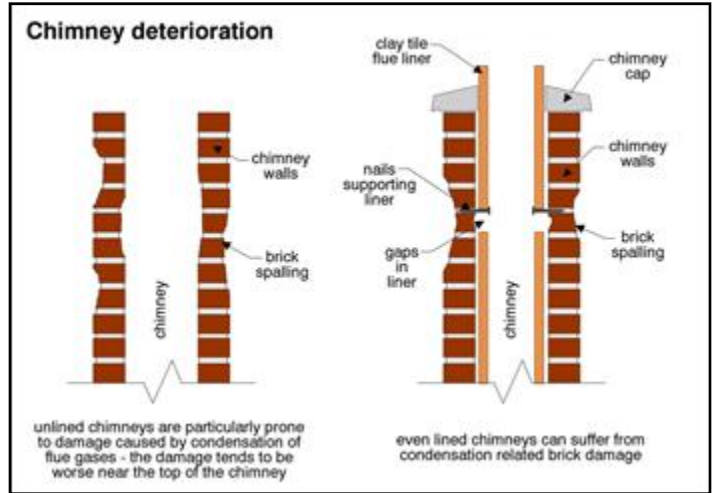
3.

Condition: • This brick chimney appears to have no liner and lacks a proper chimney cap. It is recommend when burning wood that flu liner be installed inside the brick chimney. This flu liner, installed properly is a second layer of protection from a deteriorating flu fires. Flu fires can lead to structural fires. Your Insurance company may require a liner in the chimney.

Location: Throughout chimney

Task: Provide liner

Time: Immediate

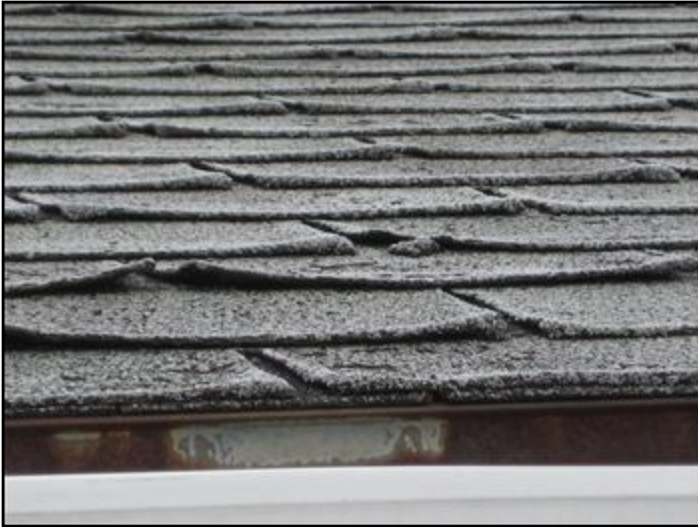
5.

1. Condition: • [Near end of life expectancy](#)

Location: Throughout Roof

Task: Replace

Time: Immediate

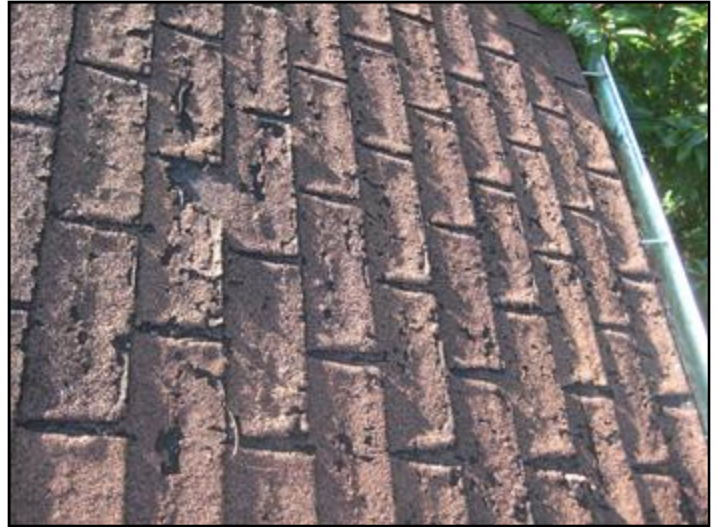
6.

2. Condition: • [Cupping, curling, clawing](#)

Risk of leaking is high.

Location: Throughout Roof

Task: Replace

Time: Immediate

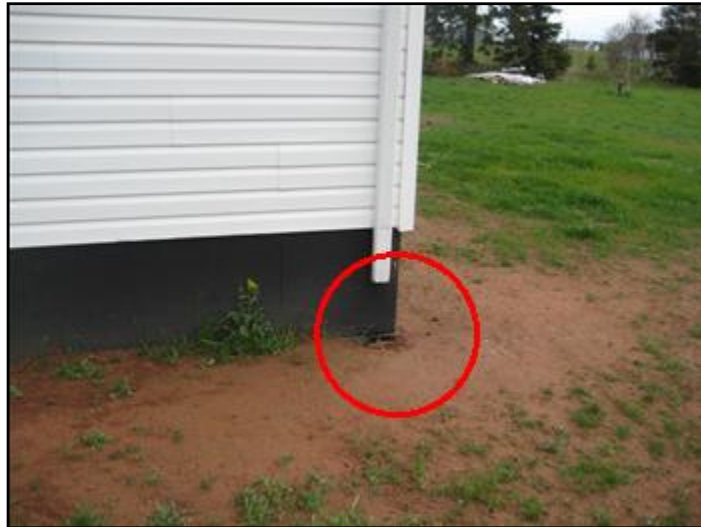
7.

3. Condition: • Should discharge 6ft. from home

Location: Northeast

Task: Provide

Time: Immediate

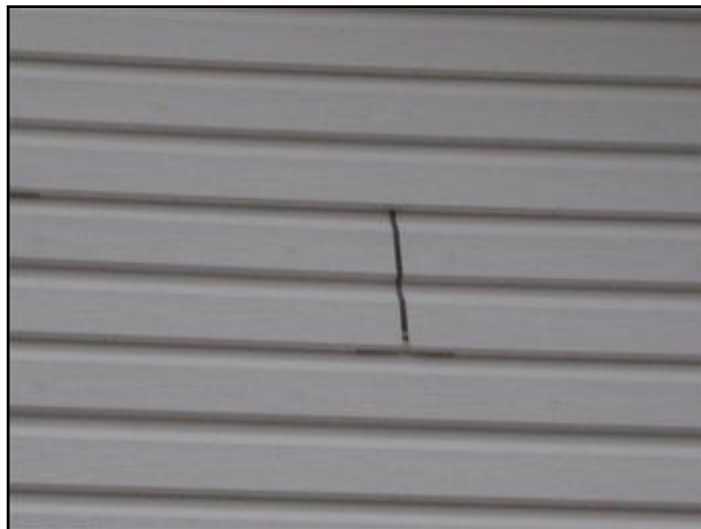
8.

4. **Condition:** • [Loose or missing pieces](#)

This gap in the siding may allow rain water to penetrate the building envelope and damage contents, finishes and/or structure.

Location: East Exterior Wall

Task: Improve - Repair gap

Time: Immediate

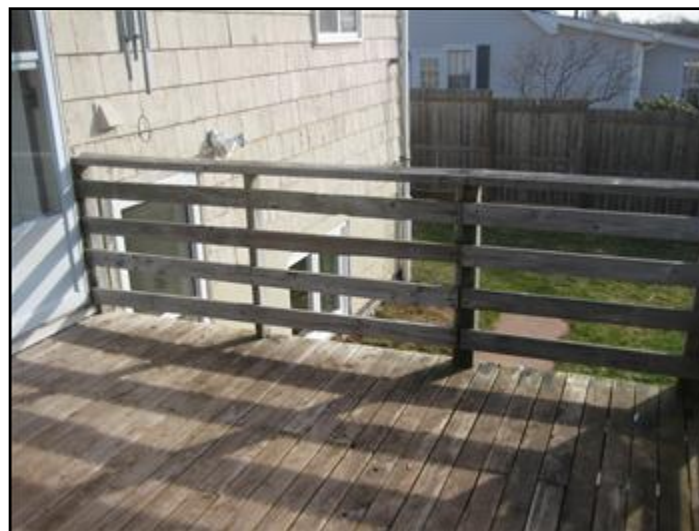
9.

5. Condition: • [Spindles climbable](#)

Considered unsafe for children to play.

Location: Deck

Task: Replace

Time: Immediate

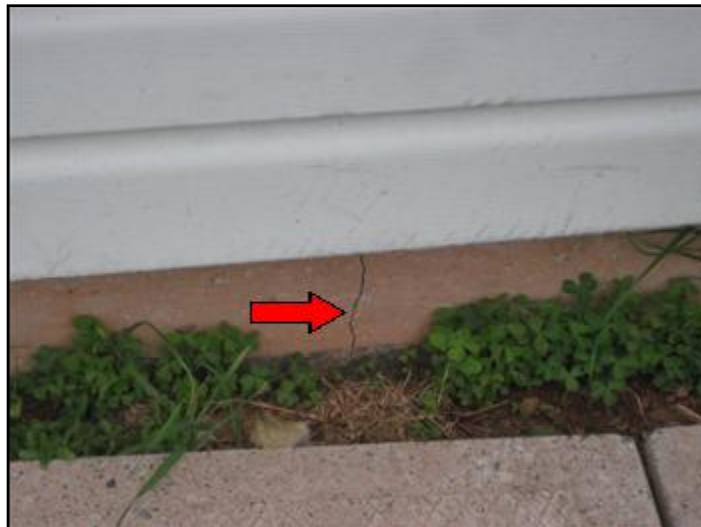
10.

- 6. Condition:** • Typical minor cracks
- Location:** East Exterior Wall
- Task:** Monitor for leaks
- Time:** Discretionary

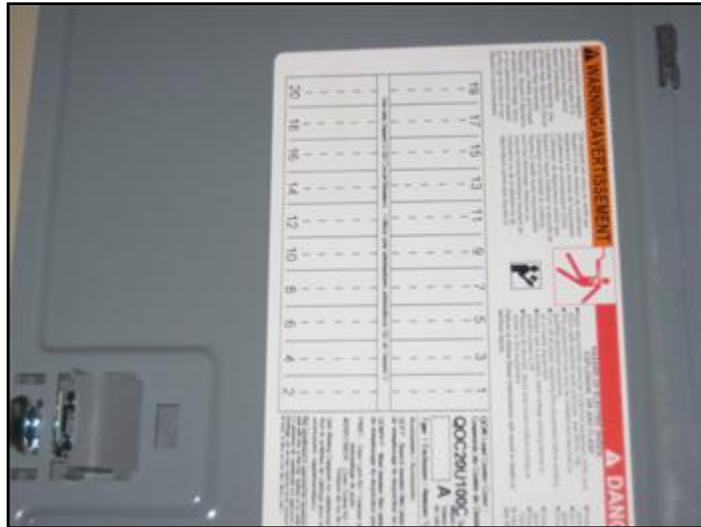
11.

7. Condition: • [Circuits not labeled](#)

Circuit breakers on the electrical panel should be labeled for servicing and in case of emergency.

Location: Basement

Task: Provide - Add labeling to electrical panel

Time: Immediate

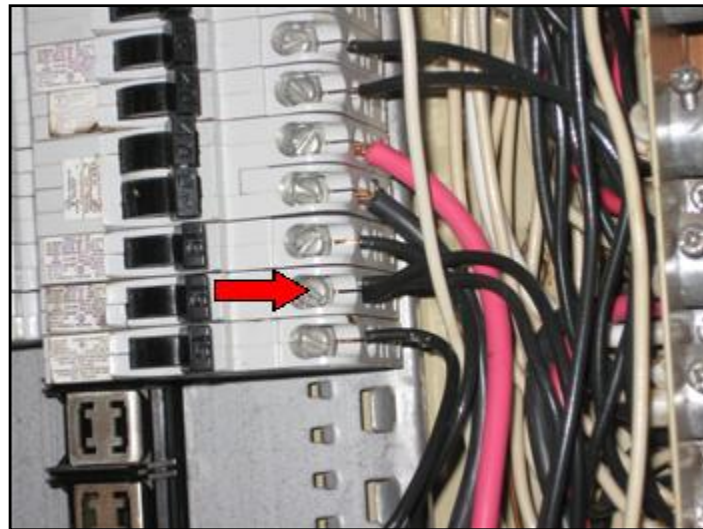
12.

8. Condition: • [Double taps](#)

Double tap in the electrical panel is a fire hazard.

Location: Basement

Task: Further evaluation

Time: Immediate

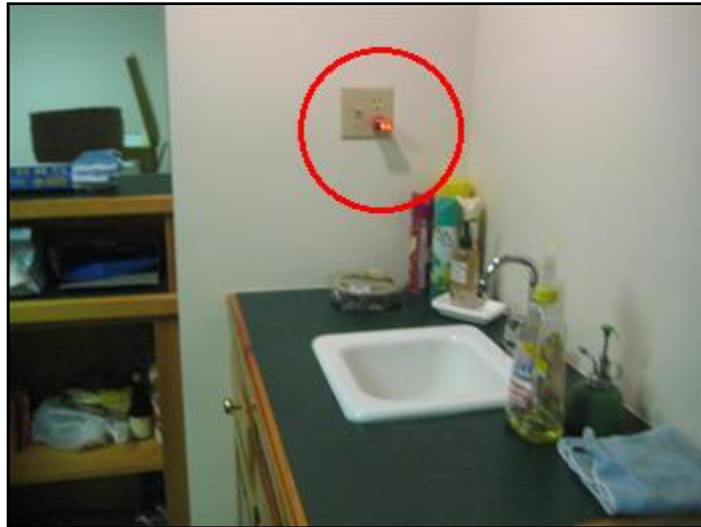
13.

10. Condition: • [No GFI \(Ground Fault Interrupter\)](#)

The risk of no GFI is electrical shock.

Location: Bathroom

Task: Provide for safety

Time: Immediate

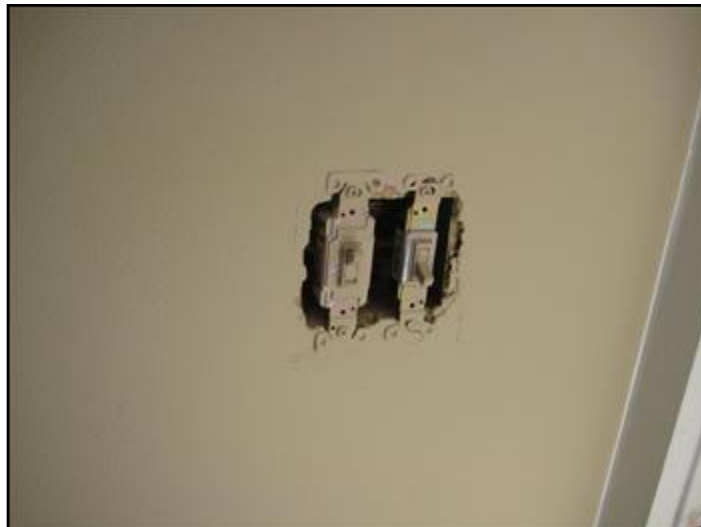
14.

11. Condition: • [Missing](#)

Risk of electrical shock

Location: First Floor Bedroom

Task: Provide cover for switches

Time: Immediate

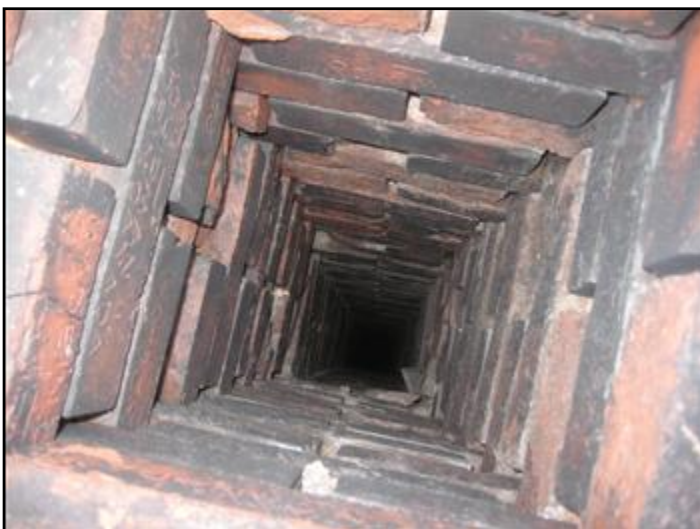
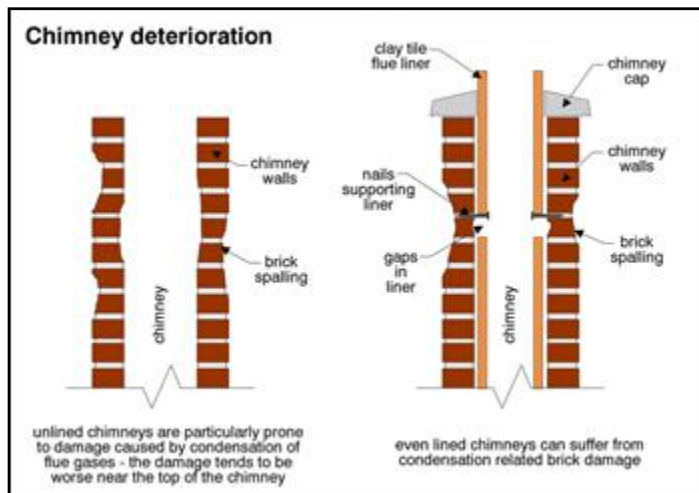
16.

15. Condition: • This brick chimney appears to have no liner and lacks a proper chimney cap. It is recommend when burning wood that flu liner be installed inside the brick chimney. This flu liner, installed properly is a second layer of protection from a deteriorating flu fires. Flu fires can lead to structural fires. Your Insurance company may require a liner in the chimney.

Location: Throughout chimney

Task: Provide liner

Time: Immediate

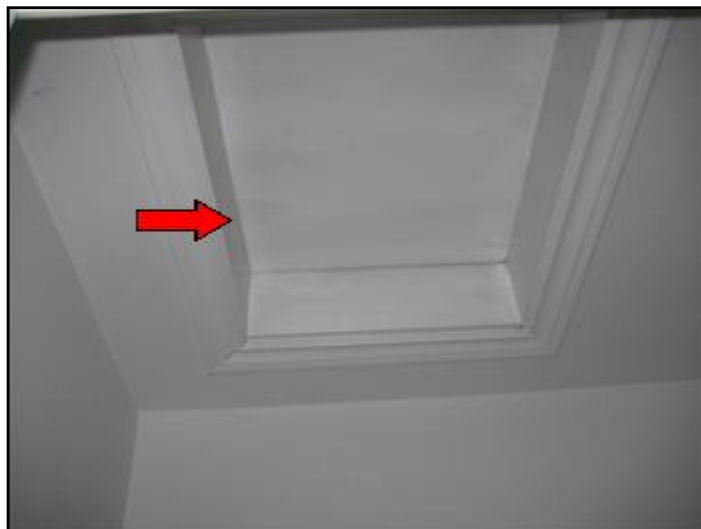
18.

16. Condition: • [Not insulated and not weatherstripped](#)

Location: Master Bedroom closet ceiling

Task: Provide insulation and weather stripping

Time: Less than 1 year

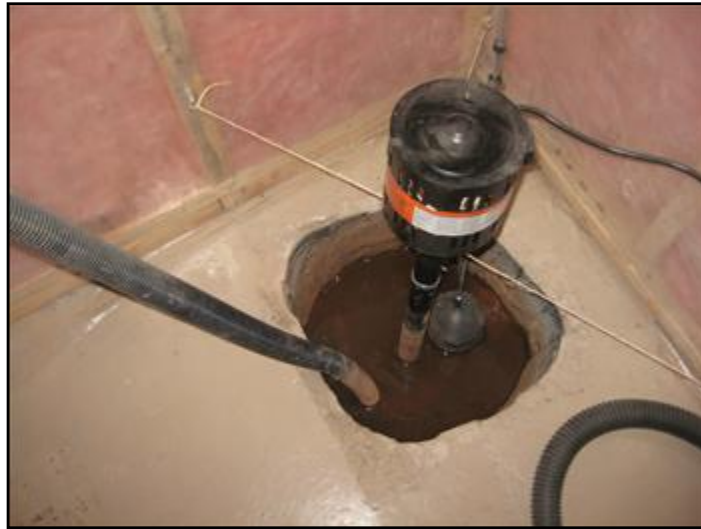
19.

17. Condition: • [Lid missing, rotted or not secure](#)

Add cover to sump pump for safety.

Location: Basement

Task: Provide

Time: Regular maintenance

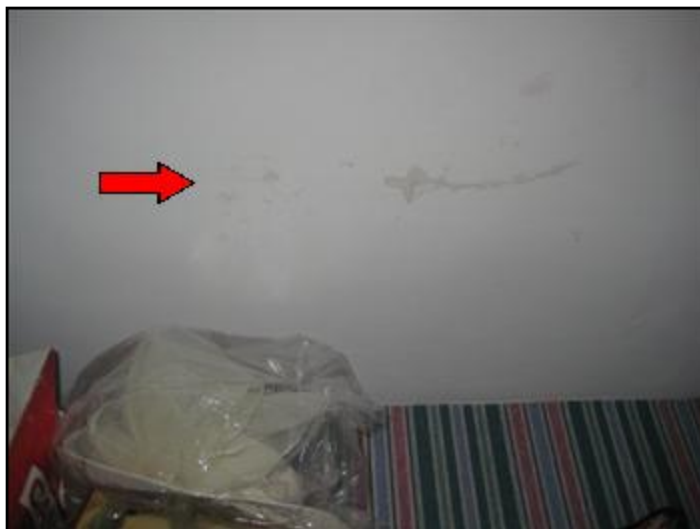
20. Condition: • Stains

This ceiling stain is dry at the time of inspection.

Location: First Floor Bedroom closet ceiling

Task: Further evaluation - Monitor

Time: Immediate

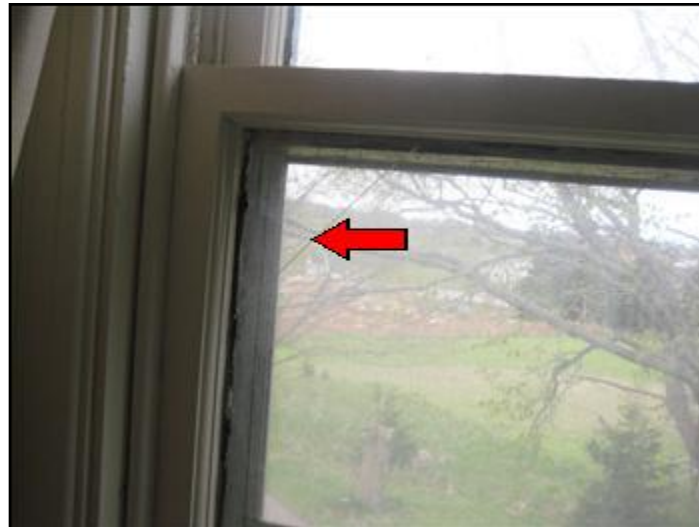
21. Condition: • [Cracked](#)

Location: First Floor Living Room

Task: Replace

Time: Immediate

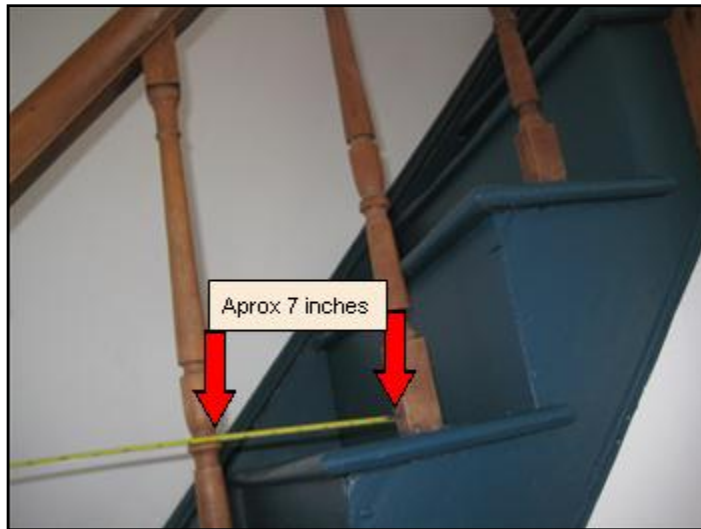
22. Condition: • [Too far apart](#)

The risk is a fall hazard for children.

Location: First Floor

Task: Improve for safety

Time: Immediate
